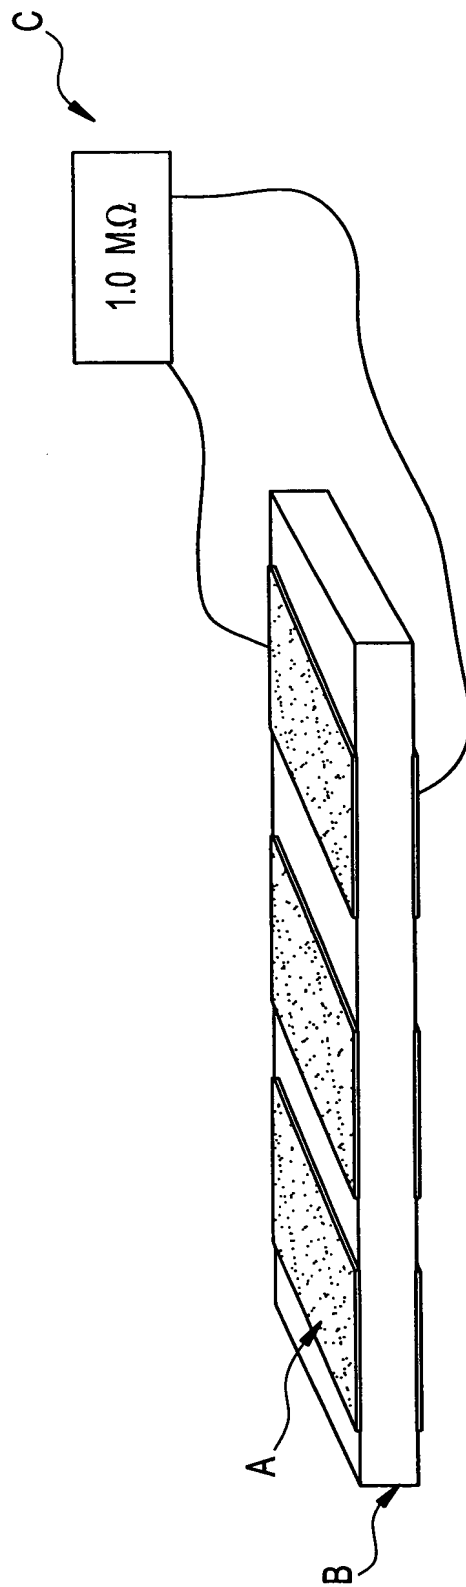
FIG. 1

A - Conductive Paint of Area "A" cm<sup>2</sup>  
B - Sample Thickness (cm)  
C - DC Resistance (Ω)

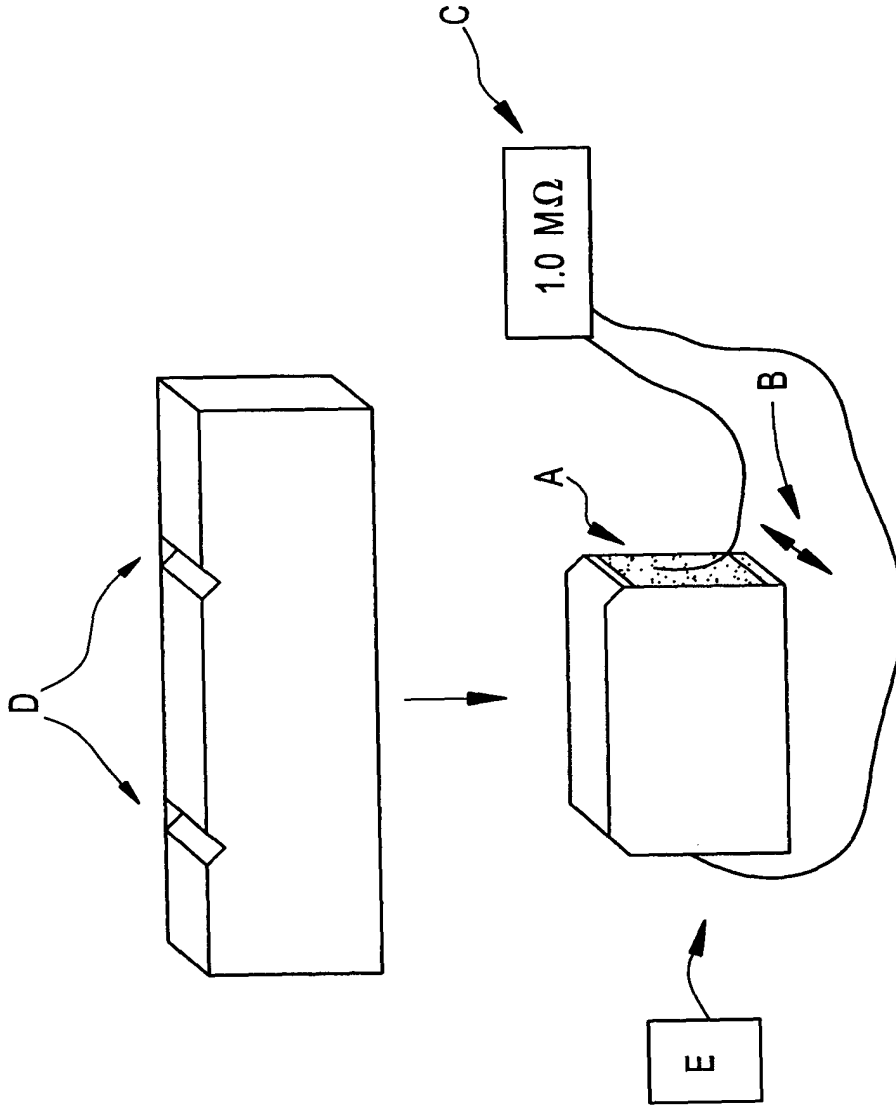
FIG. 2

D - Notch

E - Piece Broken at 77K
